**Flood Control Project Maintenance
Levee Inspections**

Fall 2016 Levee Maintenance Deficiency Summary Report

Sacramento River Basin

Reclamation District No. 0307 Lisbon

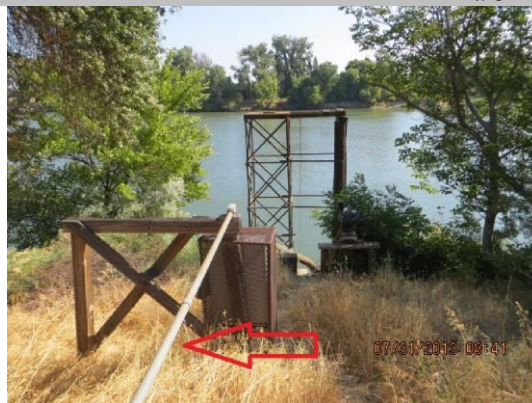
Photo 1 of 2 : UCIP_FA_2016_42934_28733.jpg

LM Start	0.45	Rating **	U	Issue No.	112
LM End	0.45	Issue Type +	En	Location *	WS
Category	Supplemental			GPS Latitude/Longitude	
				Start	End
Item	DWR UCIP Field Study			38.475542 °	38.475542 °
				-121.543566 °	-121.543566 °
DWR ID					
Comment Code					
Inspector Comment					
FS_ID:42934 DS_ID:21657 EP_NO: N/A Repair Type: Urgent Crossing Status: Found UCIP Comments: Pipe heavily corroded and will likely need replacement if 15-inch pipe sleeved through it needs replacement. Annular space not grouted between two pipes. FIELD_STRUCT_DESC: 20-inch steel irrigation pipe through the levee 16.7 feet below the crown. 15-inch pipe sleeved through this pipe. Pump missing from abandoned steel pier on WS toe. Walkway from shoulder to pier missing or abandoned. Originally included in the 1959 O&M manual. FS Date: 7/31/2013

Abandoned wakway and metal pier on WS slope.

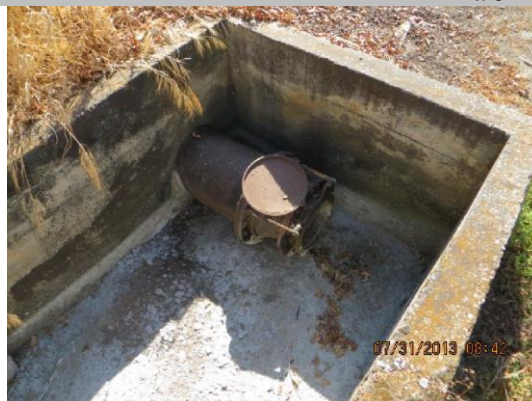
Photo 2 of 2 : UCIP_FA_2016_42934_28732.jpg

Item	DWR UCIP Field Study			38.475542 °		38.475542 °
				-121.543566 °		-121.543566 °
DWR ID						
Comment Code						
Inspector Comment						
FS_ID:42934						
DS_ID:21657						
EP_NO: N/A						
Repair Type: Urgent						
Crossing Status: Found						
UCIP Comments: Pipe heavily corroded and will likely need replacement if 15-inch pipe sleeved through it needs replacement.						
Annular space not grouted between two pipes.						
FIELD_STRUCT_DESC: 20-inch steel irrigation pipe through the levee 16.7 feet below the crown. 15-inch pipe sleeved through this pipe.						
Pump missing from abandoned steel pier on WS toe. Walkway from shoulder to pier missing or abandoned. Originally included in the 1959 O&M manual.						
FS Date: 7/31/2013

Pipe at outlet on LS toe.

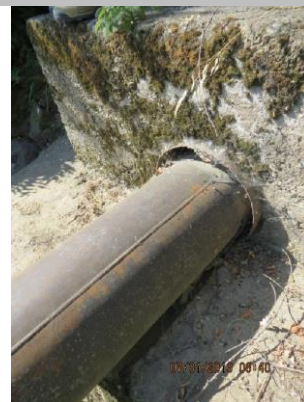
Photo 1 of 2 : UCIP_FA_2016_16743_28722.jpg

Comment Code					
Inspector Comment					
FS_ID:16743 DS_ID:21656 EP_NO: N/A Repair Type: Urgent Crossing Status: Found UCIP Comments: Pipe heavily corroded at outlet on LS toe. Holes on bottom of pipe at outlet and internal circumference shows heavy exfoliation. Pipe failing internally. Recommend replacement or video inspection before continuing use. FIELD_STRUCT_DESC: 1 of 2: 15-inch steel irrigation pipe sleeved through 21-inch steel conduit, through the levee 16.7 feet below crown. Slant pump, gate valve, concrete headwall, electrical control pane, and abandoned pier on WS slope. Concrete U-shaped outlet with flap gate on LS toe. Service pole on the landward slope with anchor. FS Date: 7/31/2013 9:44:32 AM

15-inch pipe sleeved through 21-inch pipe on WS slope at headwall.

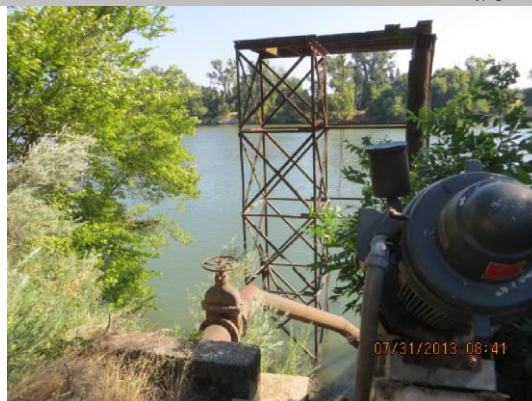
Photo 2 of 2 : UCIP_FA_2016_16743_28721.jpg

Comment Code						
Inspector Comment						
FS_ID:16743 DS_ID:21656 EP_NO: N/A Repair Type: Urgent Crossing Status: Found UCIP Comments: Pipe heavily corroded at outlet on LS toe. Holes on bottom of pipe at outlet and internal circumference shows heavy exfoliation. Pipe failing internally. Recommend replacement or video inspection before continuing use. FIELD_STRUCT_DESC: 1 of 2: 15-inch steel irrigation pipe sleeved through 21-inch steel conduit, through the levee 16.7 feet below crown. Slant pump, gate valve, concrete headwall, electrical control pane, and abandoned pier on WS slope. Concrete U-shaped outlet with flap gate on LS toe. Service pole on the landward slope with anchor. FS Date: 7/31/2013 9:44:32 AM

Pipe, gate valve, pump, and abandoned metal pier on WS slope.

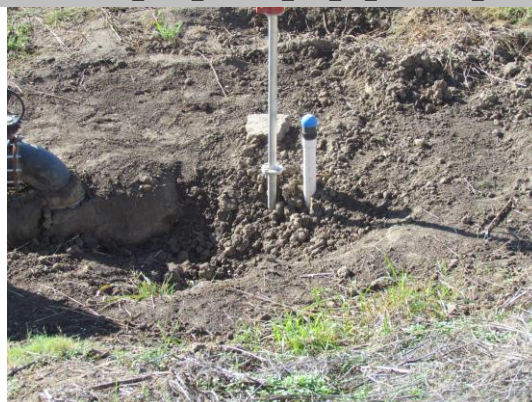
Photo 1 of 2 : FA_2016_RD0307_166_58_20161027_00107.jpg

LM Start	0.58	Rating **	M	Issue No.	58
LM End	0.58	Issue Type +	En	Location *	LS
Category	Earthen Levee			GPS Latitude/Longitude	
				Start	End
Item	Encroachments			38.474583 °	38.474583 °
				-121.541523 °	-121.541523 °
DWR ID	DWR_RD0307_01_f_2016_58				
Comment Code					
PI : Pipe					
Inspector Comment					
The sand filter and concrete foundation is under new ownership and they are working with CVFPB for a permit to retain this Encroachment.

New pipe added to the filtration system installed, no permit issued for encroachment.

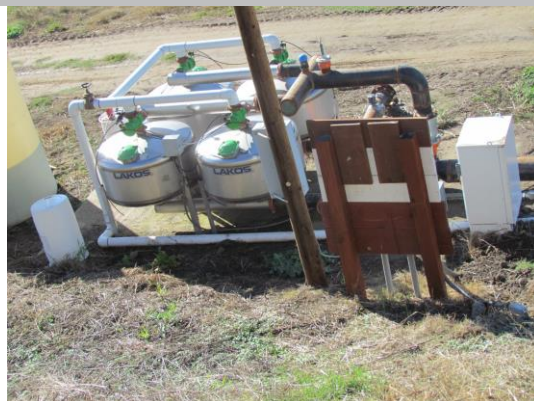
Photo 2 of 2 : FA_2016_RD0307_166_58_20161027_00108.jpg

LM Start	0.58	Rating **	M	Issue No.	58 (cont)	
LM End	0.58	Issue Type +	En	Location *	LS	
Category	Earthen Levee			GPS Latitude/Longitude		
				Start		End
Item	Encroachments			38.474583 °		38.474583 °
				-121.541523 °		-121.541523 °
DWR ID	DWR_RD0307_01_f_2016_58					
Comment Code						
PI : Pipe						
Inspector Comment						
The sand filter and concrete foundation is under new ownership and they are working with CVFPB for a permit to retain this Encroachment.

Sand filter and new power pole, panel box, electrical conduit and tanks on easement. Levee mile 0.58.

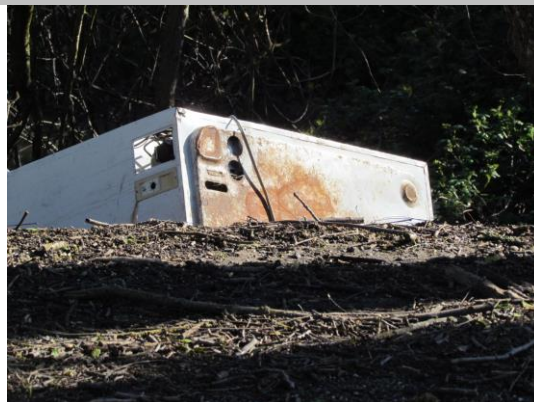
Photo 1 of 1 : FA_2016_RD0307_166_5_20160913_00003.jpg

Discarded appliance on the waterside slope.

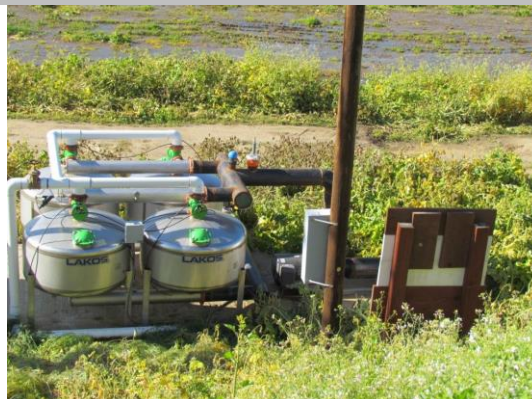
Photo 1 of 1 : FA_2016_RD0307_166_61_20160913_00012.jpg

Sand filter, power pole and panel box within the 10-foot easement.

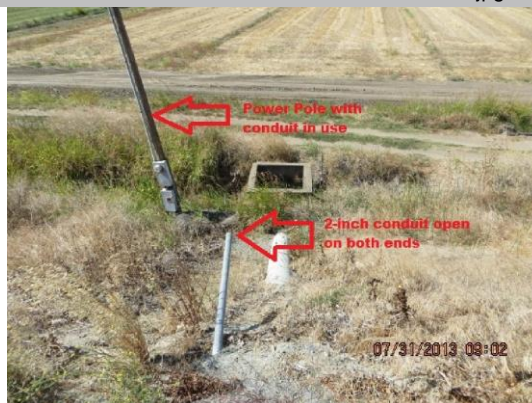
Photo 1 of 2 : UCIP_FA_2016_17103_29202.jpg

LM Start	0.93	Rating **	M	Issue No.	83
LM End	0.93	Issue Type +	En	Location *	LS
Category	Supplemental			GPS Latitude/Longitude	
				Start	End
Item	DWR UCIP Field Study			38.472872 °	38.472872 °
				-121.535542 °	-121.535542 °
DWR ID					
Comment Code					
Inspector Comment					
FS_ID:17103					
DS_ID:24014					
EP_NO: 18229					
Repair Type: Non-Urgent					
Crossing Status: Found					
UCIP Comments: Pipe open on both ends. Need to install caps.					
FIELD_STRUCT_DESC: 2 of 2: 2-inch galvanized iron pipe through the					
levee 2.0 feet below the crown (Permit No. 18229, 2007).					
FS Date: 7/31/2013

Conduit visible 2-feet below the crown on the LS shoulder.

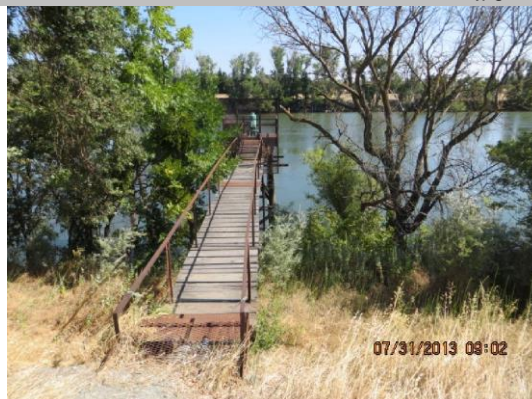
Photo 2 of 2 : UCIP_FA_2016_17103_29201.jpg

LM Start	0.93	Rating **	M	Issue No.	83 (cont)	
LM End	0.93	Issue Type +	En	Location *	LS	
Category	Supplemental			GPS Latitude/Longitude		
				Start		End
Item	DWR UCIP Field Study			38.472872 °		38.472872 °
				-121.535542 °		-121.535542 °
DWR ID						
Comment Code						
Inspector Comment						
FS_ID:17103 DS_ID:24014 EP_NO: 18229 Repair Type: Non-Urgent Crossing Status: Found UCIP Comments: Pipe open on both ends. Need to install caps. FIELD_STRUCT_DESC: 2 of 2: 2-inch galvanized iron pipe through the levee 2.0 feet below the crown (Permit No. 18229, 2007). FS Date: 7/31/2013

Conduit visible under first step of walkway to pump on WS shoulder.

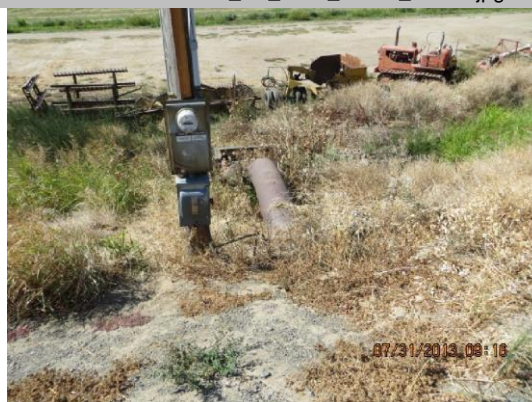
Photo 1 of 2 : UCIP_FA_2016_16764_28764.jpg

LM Start	1.08	Rating **	M	Issue No.	95
LM End	1.08	Issue Type +	En	Location *	LS
Category	Supplemental			GPS Latitude/Longitude	
				Start	End
Item	DWR UCIP Field Study			38.472870 °	38.472870 °
				-121.532750 °	-121.532750 °
DWR ID					
Comment Code					
Inspector Comment					
FS_ID:16764 DS_ID:21659 EP_NO: 8012 Repair Type: Non-Urgent Crossing Status: Found UCIP Comments: Pipe rusted through at outlet on LS of shutoff valve. This may be good indicator or corrosion throughout pipe. This is a good candidate for video inspection. FIELD_STRUCT_DESC: 1 of 2: 20-inch steel pipe through levee 7.4 feet below crown. Walkway from the waterward shoulder to pump on pile structure in stream. Distribution box and gate valve at toe of landward slope. Service pole on the landward side (Permit No. 8012, 1972). Originally included in the 1959 O&M manual. FS Date: 7/31/2013

Pipe and JP/meter on LS slope.

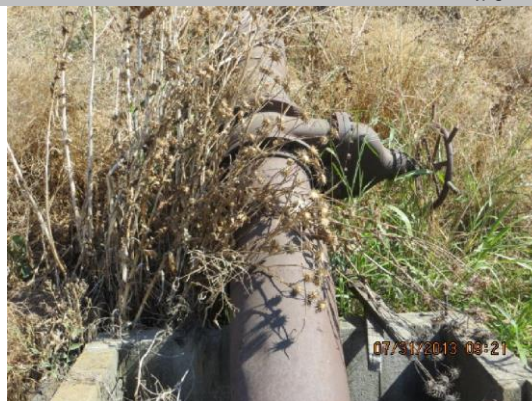
Photo 2 of 2 : UCIP_FA_2016_16764_28763.jpg

Comment Code						
Inspector Comment						
FS_ID:16764						
DS_ID:21659						
EP_NO: 8012						
Repair Type: Non-Urgent						
Crossing Status: Found						
UCIP Comments: Pipe rusted through at outlet on LS of shutoff valve.						
This may be good indicator or corrosion throughout pipe. This is a good						
candidate for video inspection.						
FIELD_STRUCT_DESC: 1 of 2: 20-inch steel pipe through levee 7.4						
feet below crown. Walkway from the waterward shoulder to pump on						
pile structure in stream. Distribution box and gate valve at toe of						
landward slope. Service pole on the landward side (Permit No. 8012,						
1972). Originally included in the 1959 O&M manual.						
FS Date: 7/31/2013

Pipe, gate valve, and concrete distribution box on LS toe.

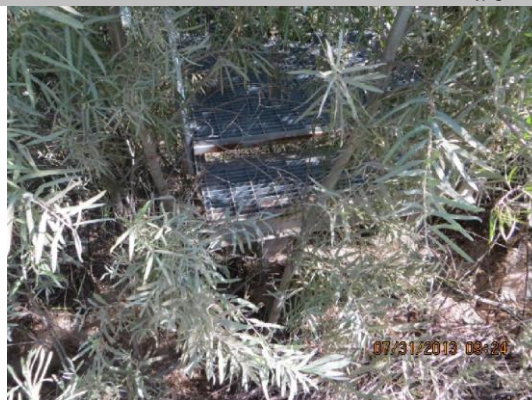
Photo 1 of 2 : UCIP_FA_2016_16766_28769.jpg

LM Start	1.08	Rating **	M	Issue No.	96
LM End	1.08	Issue Type +	En	Location *	LS
Category	Supplemental			GPS Latitude/Longitude	
				Start	End
Item	DWR UCIP Field Study			38.472874 °	38.472874 °
				-121.532611 °	-121.532611 °
DWR ID					
Comment Code					
Inspector Comment					
FS_ID:16766					
DS_ID:21660					
EP_NO: 3324					
Repair Type: Non-Urgent					
Crossing Status: Found					
UCIP Comments: Walkway completely obscured by vegetation on WS slope.					
FIELD_STRUCT_DESC: 1.25-inch electrical conduit through the levee 10.0 feet below the crown. Corrugated metal stage recorder house and walkway on the waterward slope. Service pole on the landward slope (Permit No. 3324, 1960).					
FS Date: 7/31/2013

Metal walkway visible in brush on WS slope.

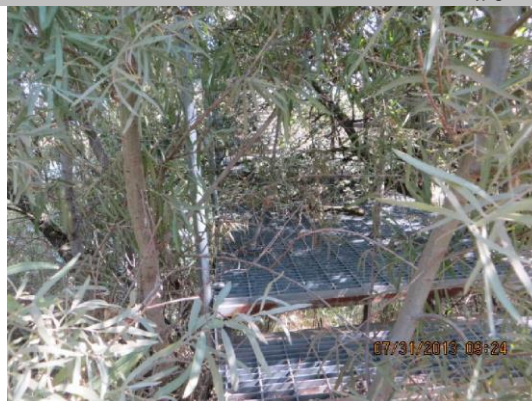
Photo 2 of 2 : UCIP_FA_2016_16766_28768.jpg

LM Start	1.08	Rating **	M	Issue No.	96 (cont)	
LM End	1.08	Issue Type +	En	Location *	LS	
Category	Supplemental			GPS Latitude/Longitude		
				Start	End	
Item	DWR UCIP Field Study			38.472874 °	38.472874 °	
				-121.532611 °	-121.532611 °	
DWR ID						
Comment Code						
Inspector Comment						
FS_ID:16766						
DS_ID:21660						
EP_NO: 3324						
Repair Type: Non-Urgent						
Crossing Status: Found						
UCIP Comments: Walkway completely obscured by vegetation on WS slope.						
FIELD_STRUCT_DESC: 1.25-inch electrical conduit through the levee 10.0 feet below the crown. Corrugated metal stage recorder house and walkway on the waterward slope. Service pole on the landward slope (Permit No. 3324, 1960).						
FS Date: 7/31/2013

Metal walkway visible in brush on WS slope.

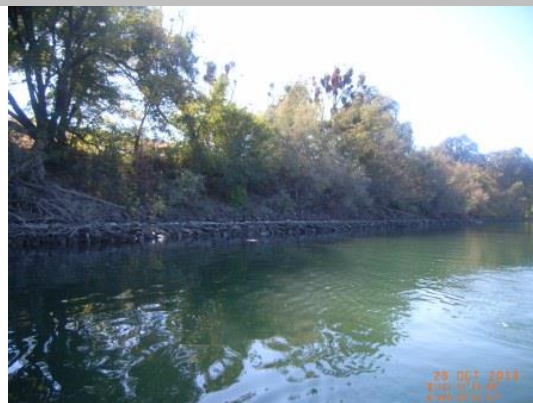
Photo 1 of 1 : FA_2016_RD0307_166_1_20160913_00001.jpg

LM Start	1.17	Rating **	M	Issue No.	1
LM End	1.31	Issue Type +	Ma	Location *	WS
Category	Supplemental			GPS Latitude/Longitude	
				Start	End
Item	2015 USACE Erosion Survey, DRAFT			38.473059 °	38.473082 °
				-121.530988 °	-121.528437 °
DWR ID	DWR_RD0307_01_s_2016_1				
Comment Code					
Inspector Comment					
2012 - Bank is slowly eroding, old rock protection starting to unravel. 2015: No observed changes. [2015 Site ID: SAC_48-6_R]

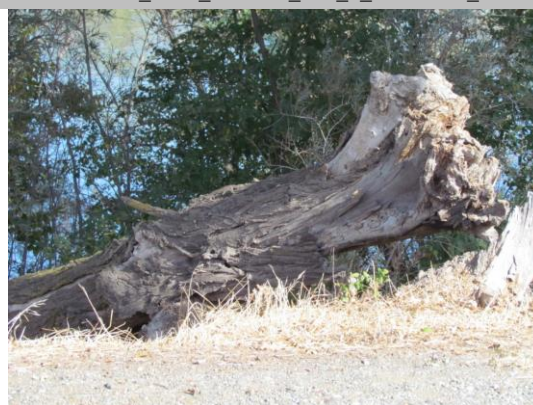
Photo 1 of 1 : FA_2016_RD0307_166_9_20160913_00005.jpg

LM Start	1.29	Rating **	U	Issue No.	9
LM End	1.29	Issue Type +	Ma	Location *	WS
Category	Earthen Levee			GPS Latitude/Longitude	
				Start	End
Item	Encroachments			38.472827 °	38.472827 °
				-121.528785 °	-121.528785 °
DWR ID	DWR_RD0307_01_f_2014_9				
Comment Code					
TR : Tree or limb					
Inspector Comment					
I have instructed the RD to schedule with his contractor to cut this tree up and have it removed from the levee section.

This tree needs to be removed from the waterside slope.

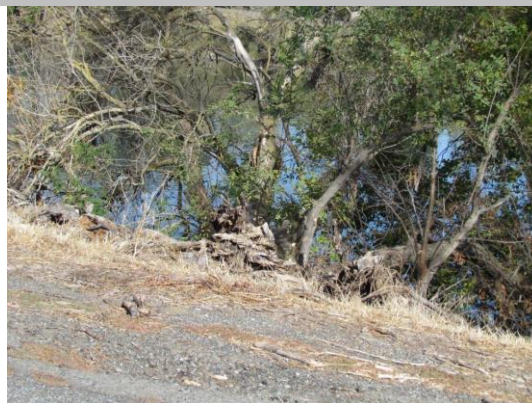
Photo 1 of 1 : FA_2016_RD0307_166_10_20160913_00006.jpg

Remove unwanted trees from waterside slope. These trees are dead and are resting on the slope.

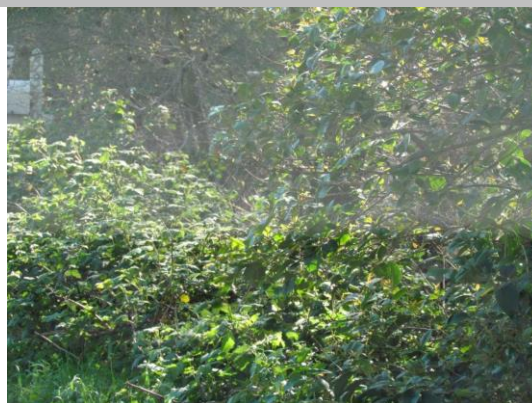
Photo 1 of 1 : FA_2016_RD0307_166_69_20160913_00013.jpg

Looking downstream from levee miles 1.59-1.66 slope covered in berry vines.

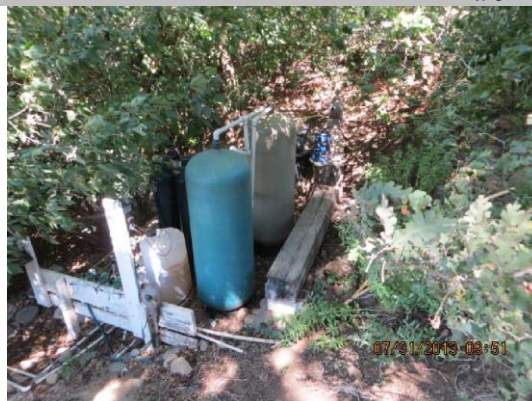
Photo 1 of 2 : UCIP_FA_2016_17106_29210.jpg

LM Start	1.62	Rating **	M	Issue No.	85
LM End	1.62	Issue Type +	En	Location *	LS
Category	Supplemental			GPS Latitude/Longitude	
				Start	End
Item	DWR UCIP Field Study			38.473129 °	38.473129 °
				-121.522717 °	-121.522717 °
DWR ID					
Comment Code					
Inspector Comment					
FS_ID:17106 DS_ID:24016 EP_NO: N/A Repair Type: Non-Urgent Crossing Status: Found UCIP Comments: No permit identified for this crossing. FIELD_STRUCT_DESC: 1 of 2: 1.5-inch PVC pipe through the levee 2-feet below the crown. Metal walkway/pier on WS slope. Possible pump, Filter, and tanks on LS slope. FS Date: 7/31/2013

Possible pump and filter plant on LS slope.

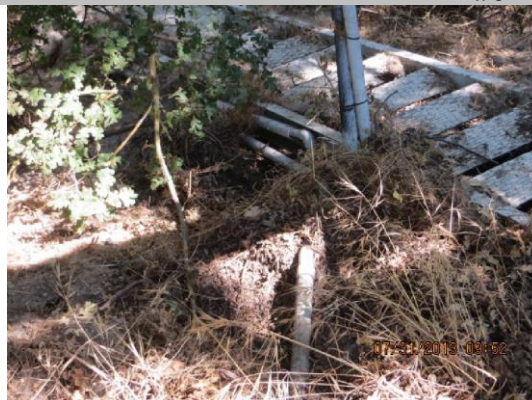
Photo 2 of 2 : UCIP_FA_2016_17106_29209.jpg

Pipes visible on WS shoulder at metal ramp.

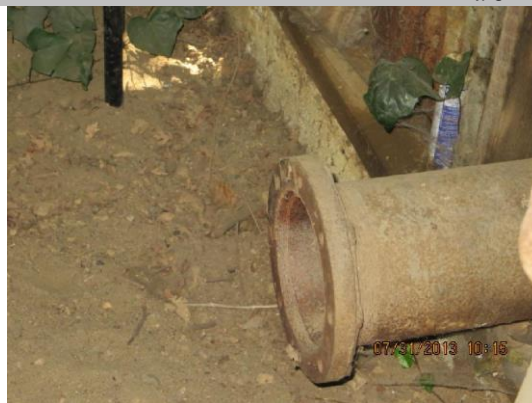
Photo 1 of 2 : UCIP_FA_2016_16805_28806.jpg

LM Start	1.82	Rating **	M	Issue No.	97
LM End	1.82	Issue Type +	En	Location *	LS
Category	Supplemental			GPS Latitude/Longitude	
				Start	End
Item	DWR UCIP Field Study			38.473249 °	38.473249 °
				-121.519095 °	-121.519095 °
DWR ID					
Comment Code					
Inspector Comment					
FS_ID:16805 DS_ID:21663 EP_NO: 8016 Repair Type: Non-Urgent Crossing Status: Indicator Found UCIP Comments: Needs to be abandoned properly. FIELD_STRUCT_DESC: *ABANDONED* 8-inch iron pipe through the levee 15.7 feet below the crown. No connection in pump house on the LS toe, but 8-inch outlet pipe remains at connection from pumphouse to concrete standpipe. (Permit No. 8016, 1972). Pipe capped at both ends according to Permit No. 18209 for replacement pipe. Originally included in the 1959 O&M manual. FS Date: 7/31/2013

Remnants of abandoned pipe visible in pumphouse on LS toe.

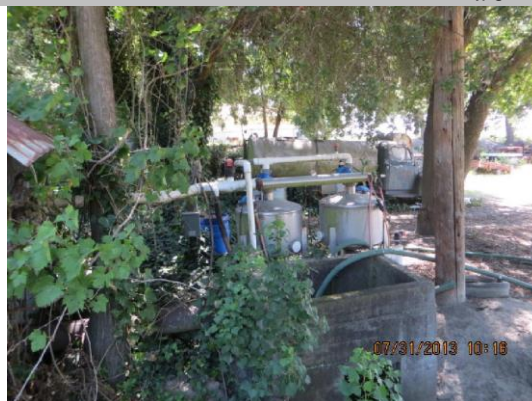
Photo 2 of 2 : UCIP_FA_2016_16805_28805.jpg

LM Start	1.82	Rating **	M	Issue No.	97 (cont)	
LM End	1.82	Issue Type +	En	Location *	LS	
Category	Supplemental			GPS Latitude/Longitude		
				Start		End
Item	DWR UCIP Field Study			38.473249 °		38.473249 °
				-121.519095 °		-121.519095 °
DWR ID						
Comment Code						
Inspector Comment						
FS_ID:16805 DS_ID:21663 EP_NO: 8016 Repair Type: Non-Urgent Crossing Status: Indicator Found UCIP Comments: Needs to be abandoned properly. FIELD_STRUCT_DESC: *ABANDONED* 8-inch iron pipe through the levee 15.7 feet below the crown. No connection in pump house on the LS toe, but 8-inch outlet pipe remains at connection from pumphouse to concrete standpipe. (Permit No. 8016, 1972). Pipe capped at both ends according to Permit No. 18209 for replacement pipe. Originally included in the 1959 O&M manual. FS Date: 7/31/2013

Concrete distribution box at LS toe.

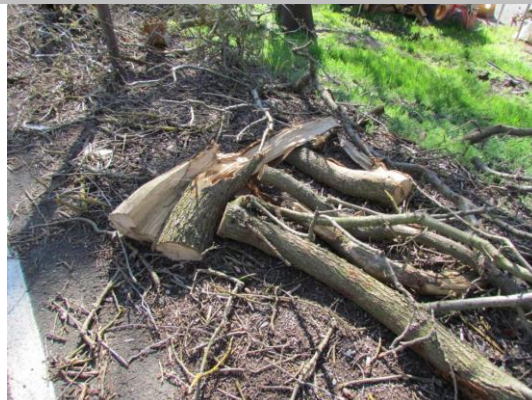
Photo 1 of 3 : FA_2016_RD0307_166_73_20160913_00014.jpg

Looking downstream from levee mile 1.86 cut up fallen tree on shoulder.

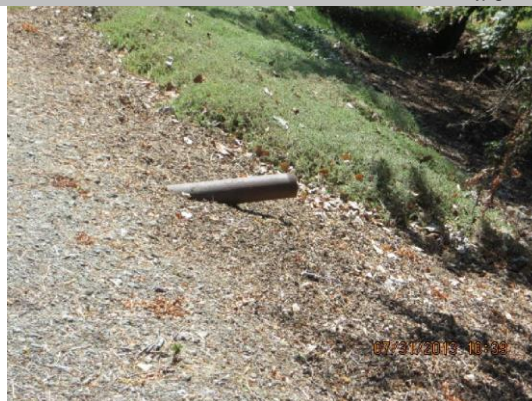
Photo 1 of 2 : UCIP_FA_2016_22709_38412.jpg

LM Start	2.21	Rating **	M	Issue No.	103
LM End	2.21	Issue Type +	En	Location *	LS
Category	Supplemental			GPS Latitude/Longitude	
				Start	End
Item	DWR UCIP Field Study			38.472238 °	38.472238 °
				-121.512032 °	-121.512032 °
DWR ID					
Comment Code					
Inspector Comment					
FS_ID:22709					
DS_ID:21665					
EP_NO: N/A					
Repair Type: Non-Urgent					
Crossing Status: Found					
UCIP Comments: Pipe abandoned and should be done so properly.					
FIELD_STRUCT_DESC: 5-inch steel irrigation pipe through the levee					
2.0-feet below the crown. Pipe open on both ends. Originally included					
in the 1959 O&M manual.					
FS Date: 7/31/2013

Pipe visible on LS shoulder.

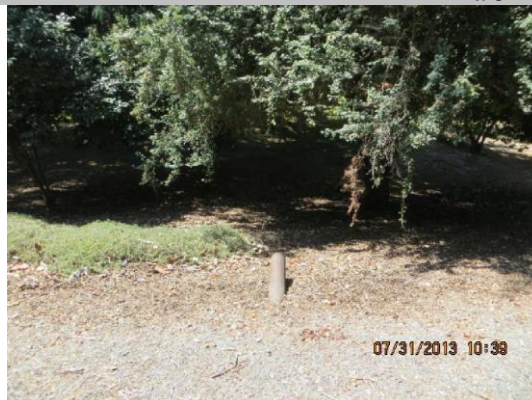
Photo 2 of 2 : UCIP_FA_2016_22709_38411.jpg

Pipe visible on LS shoulder.

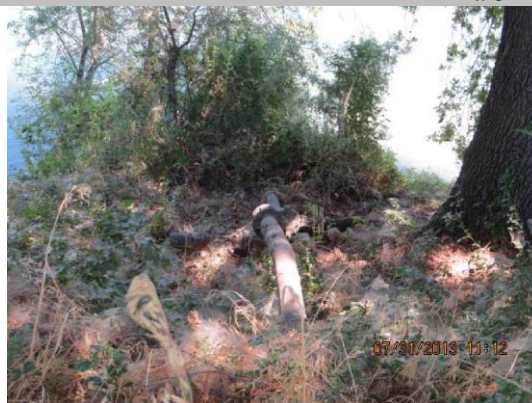
Photo 1 of 2 : UCIP_FA_2016_40794_28823.jpg

LM Start	2.42	Rating **	M	Issue No.	113
LM End	2.42	Issue Type +	En	Location *	WS
Category	Supplemental			GPS Latitude/Longitude	
				Start	End
Item	DWR UCIP Field Study			38.471093 °	38.471093 °
				-121.508429 °	-121.508429 °
DWR ID					
Comment Code					
Inspector Comment					
FS_ID:40794					
DS_ID:21667					
EP_NO: N/A					
Repair Type: Non-Urgent					
Crossing Status: Found					
UCIP Comments: Pipe appears abandoned and if so should be done so properly.					
FIELD_STRUCT_DESC: 6-inch steel irrigation pipe through the levee 3.0 feet below the crown. Pump and gate valve on the waterward slope. 36-inch concrete standpipe on LS toe. Originally included in the 1959 O&M manual.					
FS Date: 7/31/2013

Pump and gate valve on WS slope.

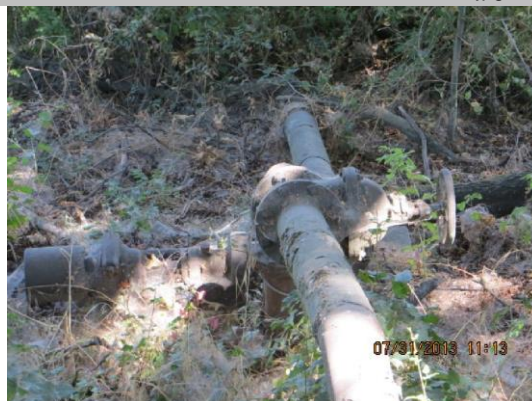
Photo 2 of 2 : UCIP_FA_2016_40794_28822.jpg

Pump and gate valve on WS slope.

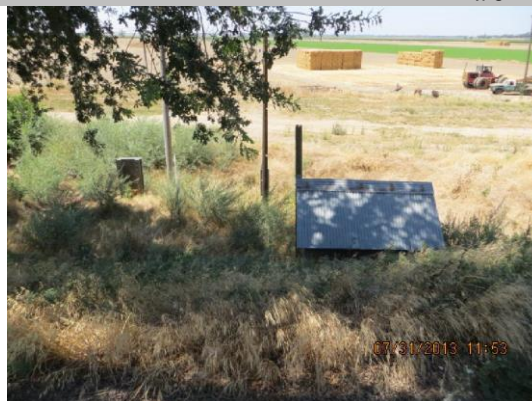
Photo 1 of 2 : UCIP_FA_2016_16815_28850.jpg

Pumphouse on LS toe.

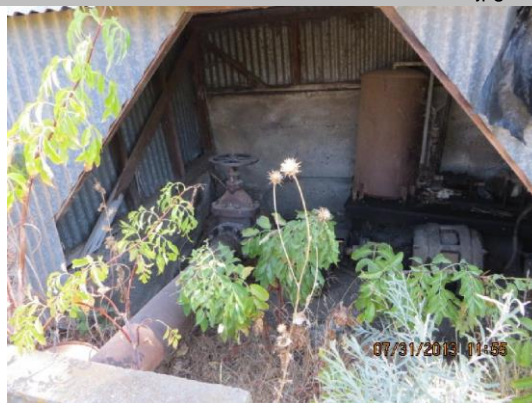
Photo 2 of 2 : UCIP_FA_2016_16815_28849.jpg

Pump and gate valve inside pumphouse on LS toe.

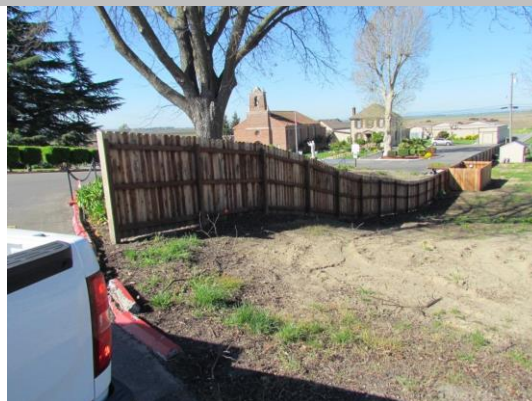
Photo 1 of 1 : FA_2016_RD0307_166_79_20160913_00018.jpg

Looking down the landside slope and shoulder of levee mile 3.19 new replacement of a solid wall wooden fence.

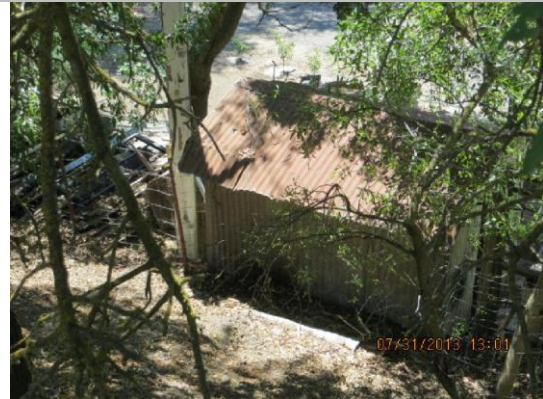
Photo 1 of 2 : UCIP_FA_2016_16843_28881.jpg

Pumphouse on LS toe. No access due to fence along toe.

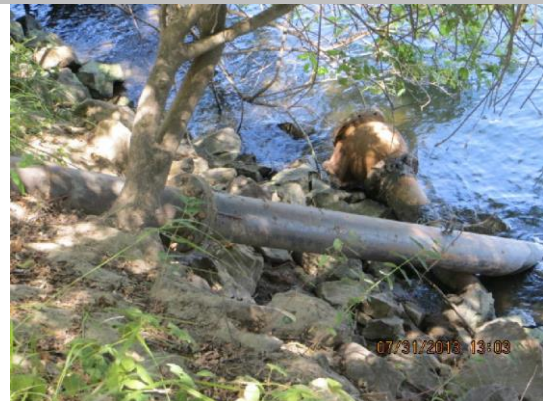
Photo 2 of 2 : UCIP_FA_2016_16843_28880.jpg

Pipe visible on WS toe.

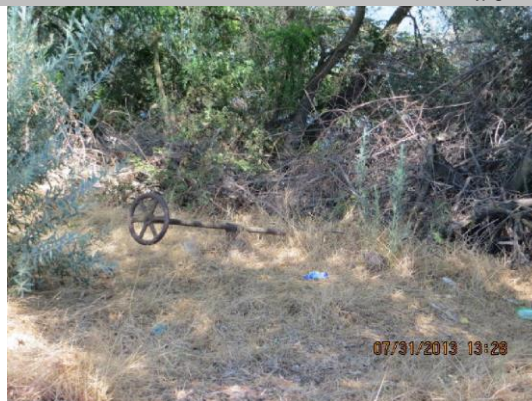
Photo 1 of 2 : UCIP_FA_2016_16923_28978.jpg

Gate valve actuator on WS slope.

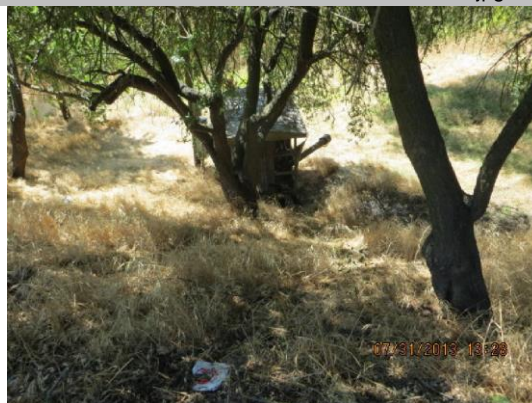
Photo 2 of 2 : UCIP_FA_2016_16923_28977.jpg

Pumphouse on LS toe.

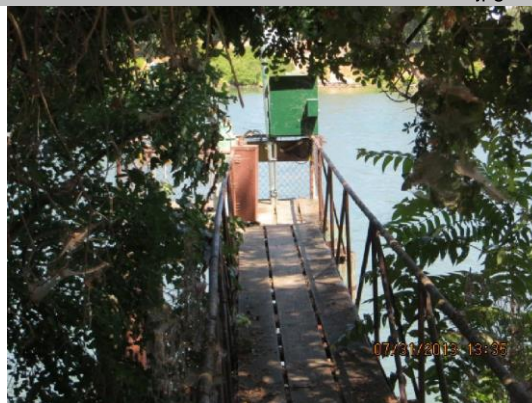
Photo 2 of 2 : UCIP_FA_2016_16924_28981.jpg

Pump and electrical controls on Pier at WS slope.

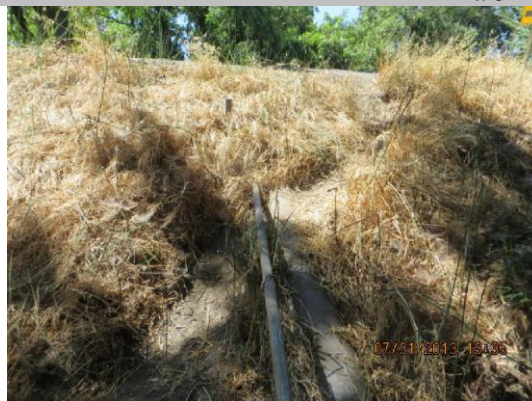
Photo 1 of 2 : UCIP_FA_2016_16925_28984.jpg

Conduit visible on WS slope.

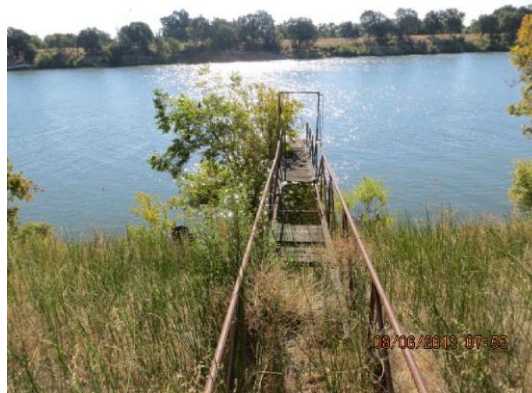
Photo 1 of 2 : UCIP_FA_2016_16983_29022.jpg

Metal walkway to pump on pier and gate valve actuator on WS slope.

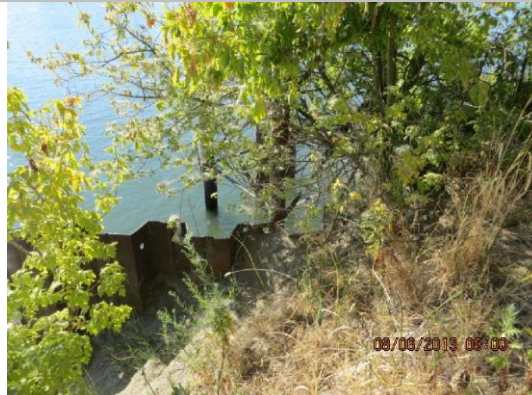
Photo 2 of 2 : UCIP_FA_2016_16983_29021.jpg

Sheet pile wall at WS toe.

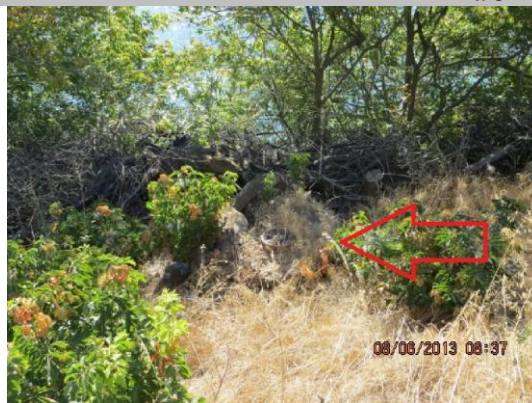
Photo 1 of 2 : UCIP_FA_2016_17128_29261.jpg

Wooden lid at gate valve in CMP riser on WS slope.

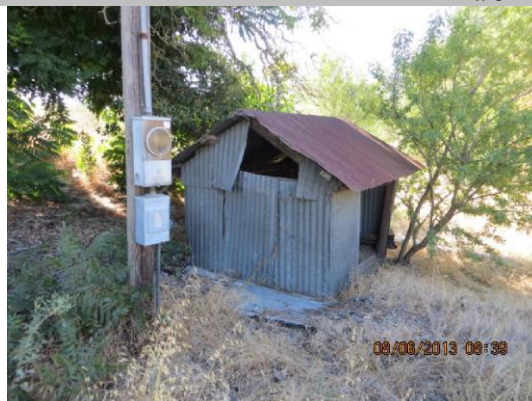
Photo 2 of 2 : UCIP_FA_2016_17128_29260.jpg

Power Pole, meter, and pumphouse on LS toe.

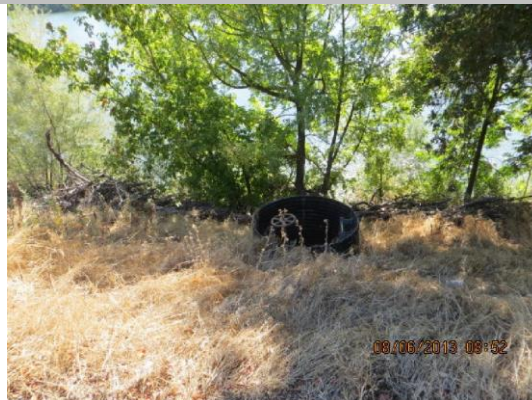
Photo 1 of 2 : UCIP_FA_2016_22670_38290.jpg

Slide gate in riser on WS slope.

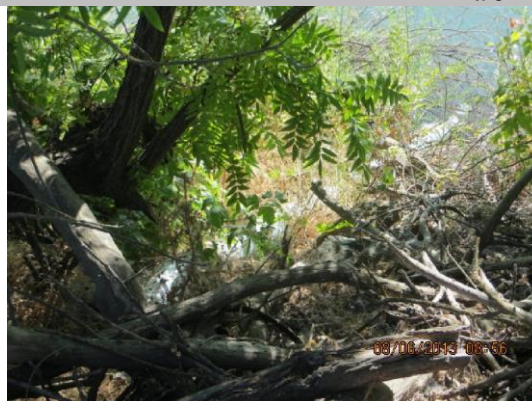
Photo 2 of 2 : UCIP_FA_2016_22670_38289.jpg

Pipe visible on WS slope.

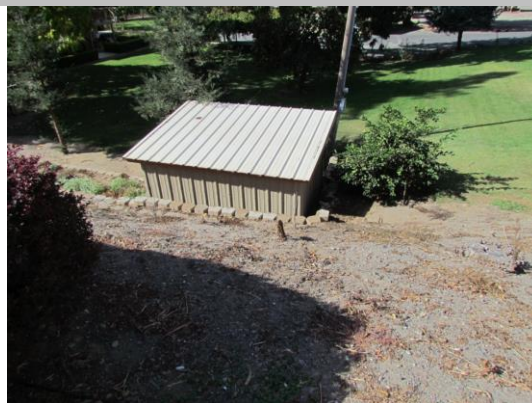
Photo 1 of 1 : FA_2016_RD0307_166_26_20160913_00007.jpg

This pump house was built without CVFPB Permit.

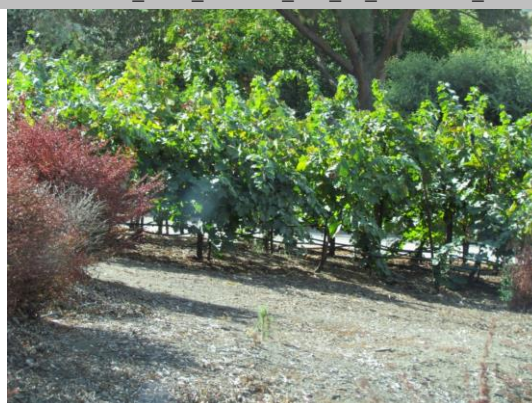
Photo 1 of 1 : FA_2016_RD0307_166_27_20160913_00008.jpg

Unwanted grapes placed on levee slope, these grapes has been reported to both district and CVFPB. No permit.

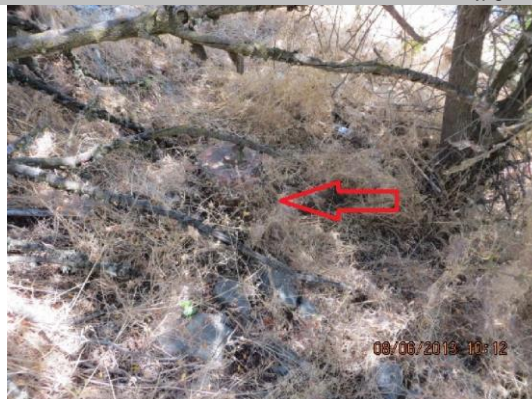
Photo 2 of 2 : UCIP_FA_2016_17183_29320.jpg

Gate valve on WS slope.

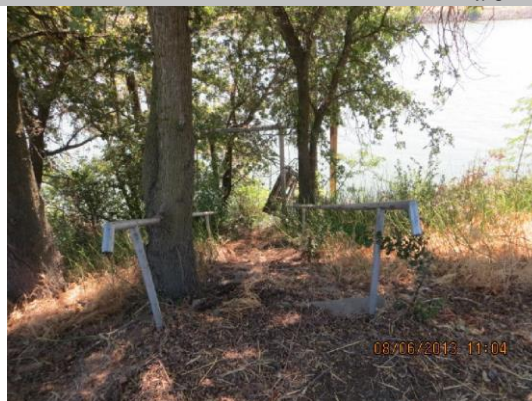
Photo 1 of 2 : UCIP_FA_2016_17184_29326.jpg

Pipe and gate valve on WS slope just downstream from stairs.

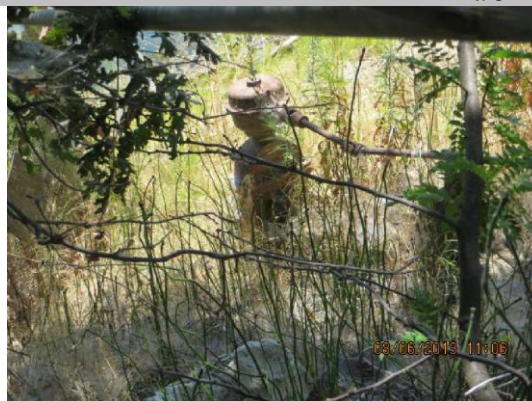
Photo 2 of 2 : UCIP_FA_2016_17184_29325.jpg

Gate valve on WS slope.

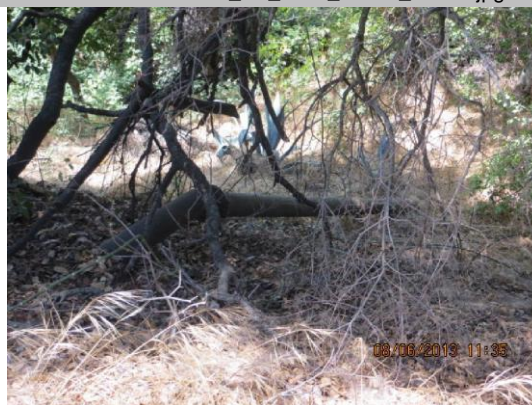
Photo 1 of 1 : UCIP_FA_2016_22671_38293.jpg

Pipe visible on LS slope.

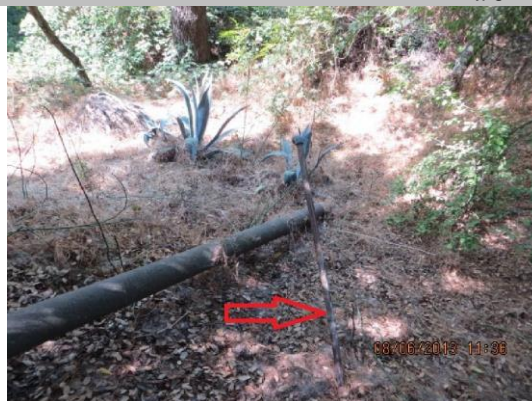
Photo 1 of 1 : UCIP_FA_2016_22672_38296.jpg

Abandoned electrical conduit next to pipe on LS slope.

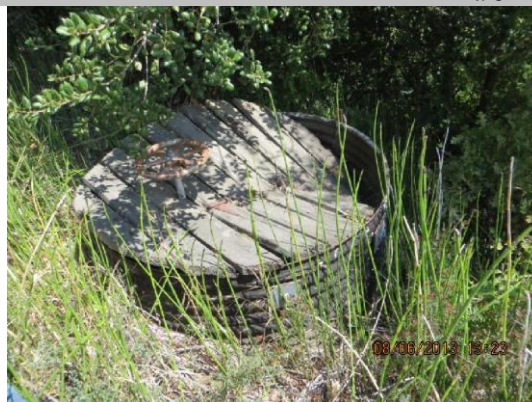
Photo 1 of 2 : UCIP_FA_2016_22710_38415.jpg

Gate valve in 5-foot diameter CMP riser on WS slope.

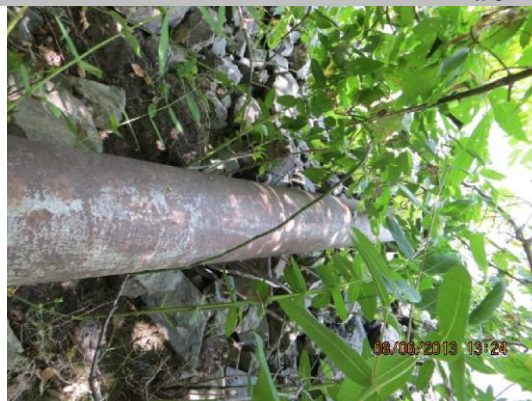
Photo 2 of 2 : UCIP_FA_2016_22710_38414.jpg

Pipe visible on WS slope.

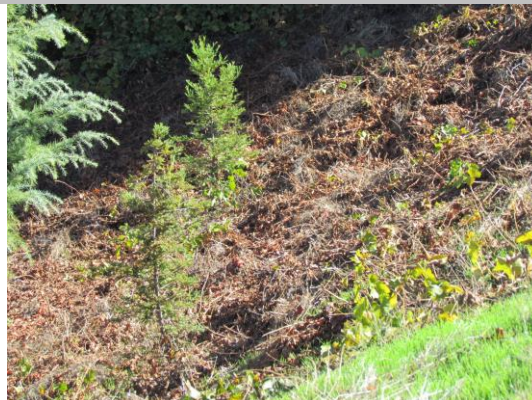
Photo 1 of 5 : FA_2016_RD0307_166_28_20161027_00101.jpg

RD 307 looking back upstream at the levee toe and slope are young unauthorized red woods and one taller redwood planted prior to this inspection.

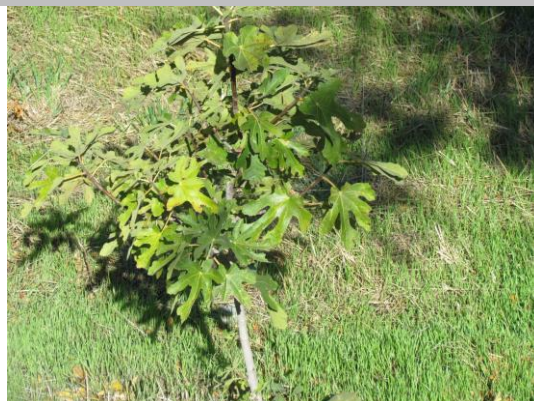
Photo 4 of 5 : FA_2016_RD0307_166_28_20161027_00103.jpg

RD 307 Looking downstream levee slope and toe are young unauthorized fig trees.

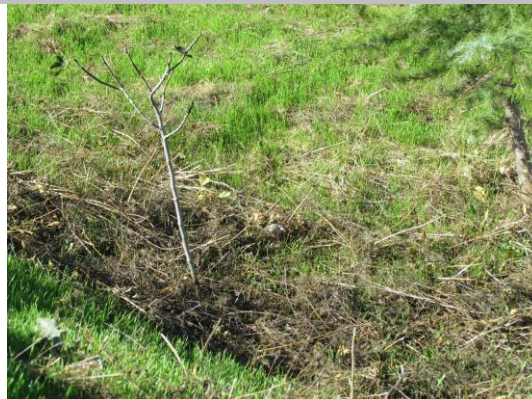
Photo 5 of 5 : FA_2016_RD0307_166_28_20161027_00104.jpg

RD 307 Looking downstream from the levee slope and toe are more young unauthorized fig trees.

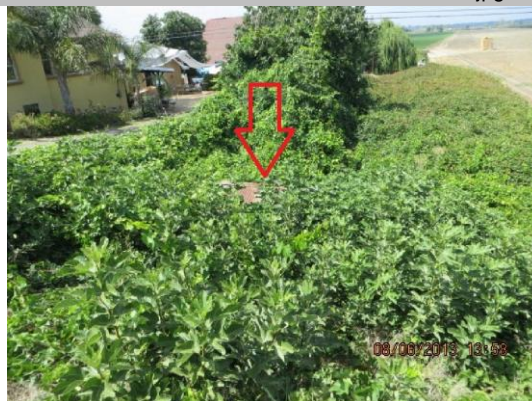
Photo 1 of 2 : UCIP_FA_2016_40546_29421.jpg

Pumphouse on LS toe.

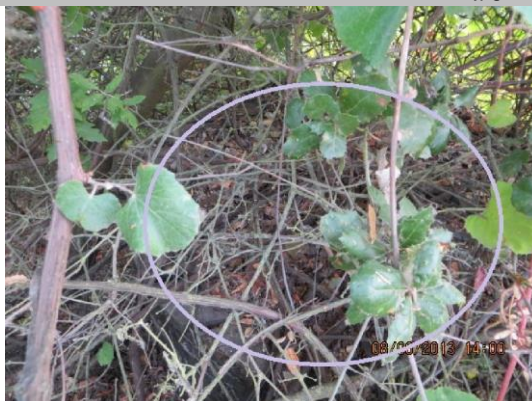
Photo 2 of 2 : UCIP_FA_2016_40546_29420.jpg

Gate valve in 5-foot diameter CMP riser on WS slope.

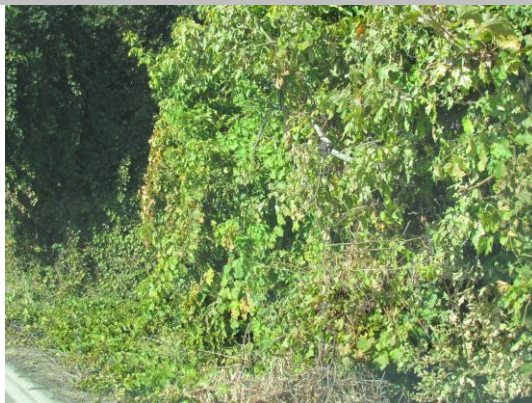
Photo 1 of 1 : FA_2016_RD0307_166_66_20161027_00105.jpg

RD 307 levee mile 5.39-5.49 landside shoulder and slope.

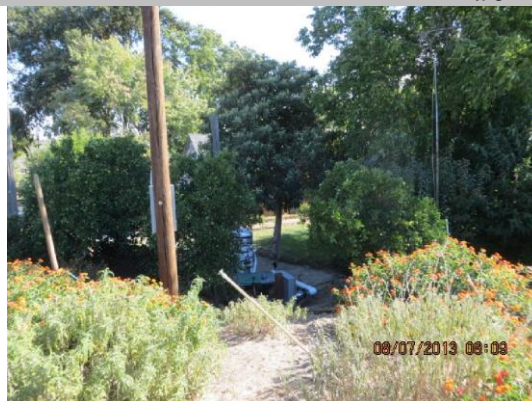
Photo 1 of 2 : UCIP_FA_2016_17287_29423.jpg

Pump and appurtenances on LS toe.

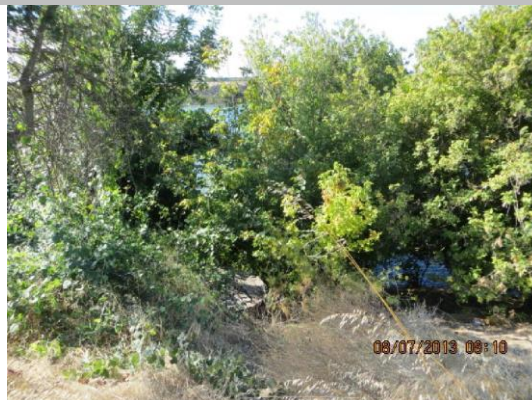
Photo 2 of 2 : UCIP_FA_2016_17287_29422.jpg

Gate valve in 5-foot diameter CMP riser on WS slope.

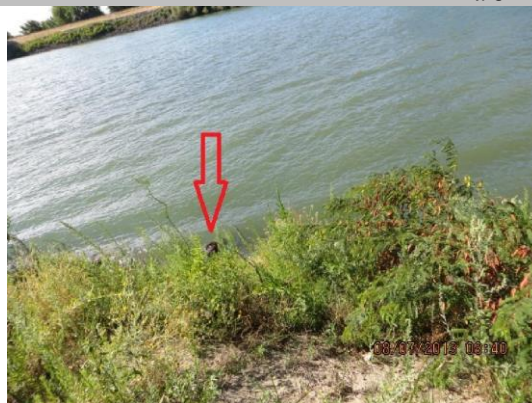
Photo 1 of 2 : UCIP_FA_2016_17343_29442.jpg

Pipe visible on WS toe.

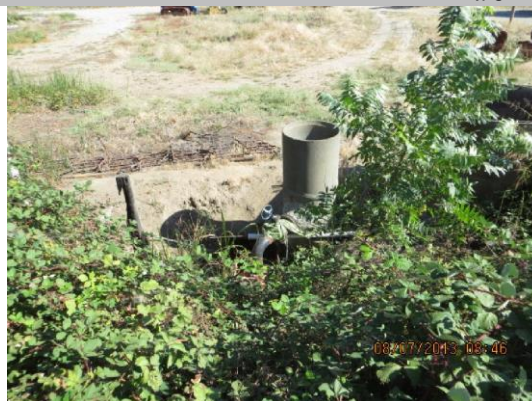
Photo 2 of 2 : UCIP_FA_2016_17343_29441.jpg

Pump, butterfly valve, vent, and concrete standpipe on LS toe.

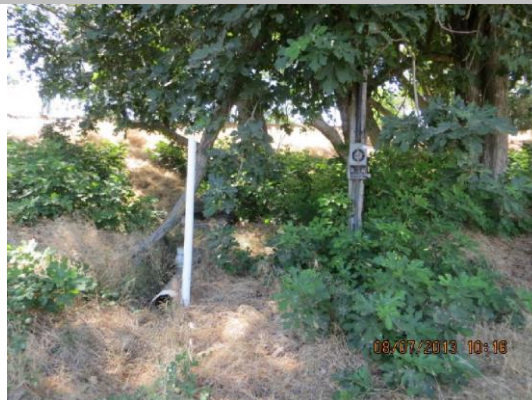
Photo 1 of 2 : UCIP_FA_2016_22711_38419.jpg

Power pole and meter off LS toe.

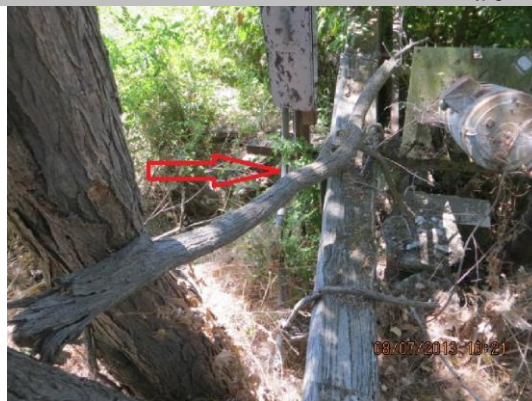
Photo 2 of 2 : UCIP_FA_2016_22711_38418.jpg

Electrical conduit visible at panel next to slant pump on WS slope.

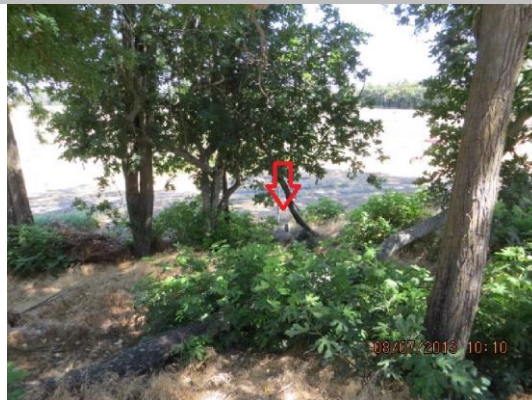
Photo 1 of 2 : UCIP_FA_2016_22712_38422.jpg

Pipe on LS toe.

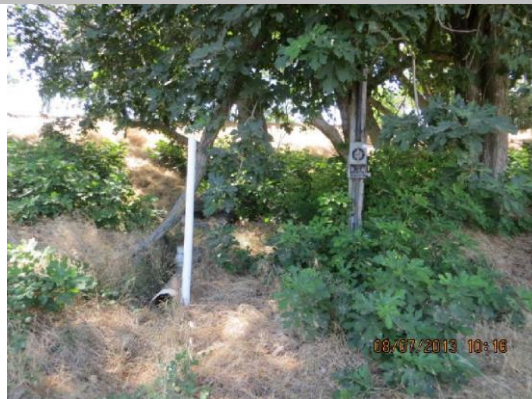
Photo 2 of 2 : UCIP_FA_2016_22712_38421.jpg

Pipe, power pole, and meter on LS toe.

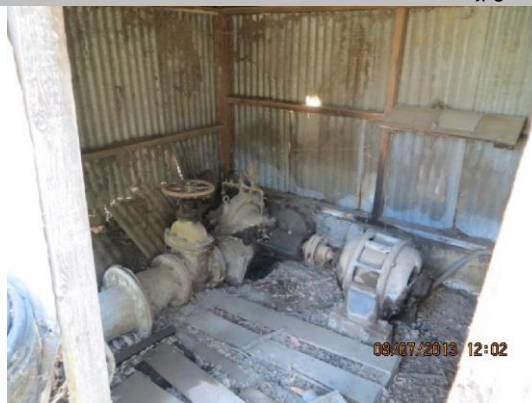
Photo 2 of 2 : UCIP_FA_2016_17385_29488.jpg

Pump and gate valve inside pumphouse on LS toe.

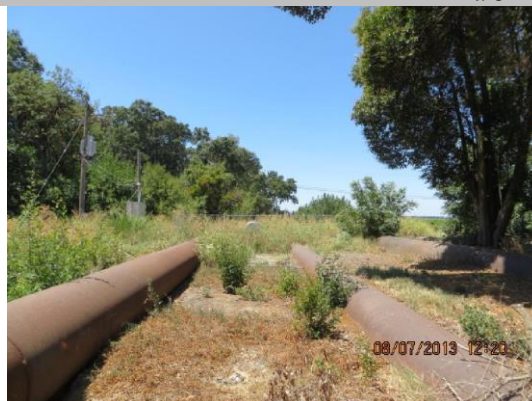
Photo 1 of 2 : UCIP_FA_2016_17404_29504.jpg

Pipe visible on LS toe to pumping plant 200-feet off LS toe.

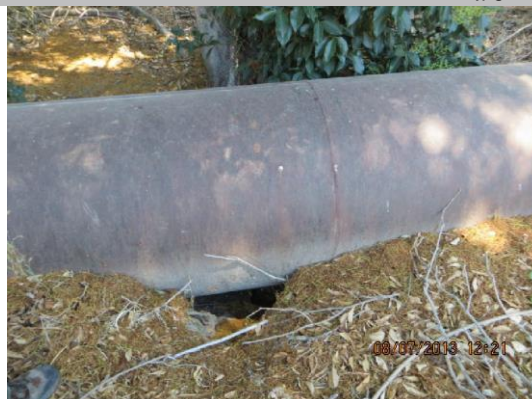
Photo 2 of 2 : UCIP_FA_2016_17404_29503.jpg

Animal activity/burrows under pipe on LS at various locations.
